The Features of Tateyama Sabo and their Value

PII-38

II Tateyama Sabo, historical sabo facilities under the Mt. Tonbi landslide

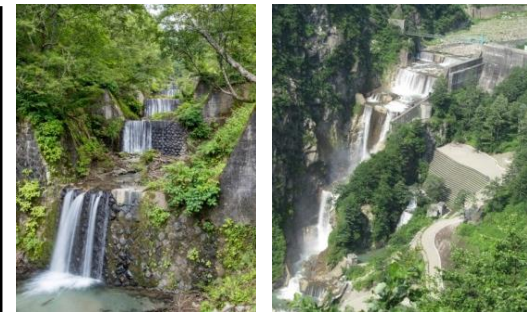
① Dorodani Sabo Dams (sediment generation control) ② Shiraiwa Sabo Dam (Sediment check)

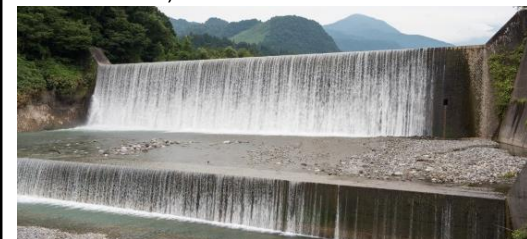
③ Hongu Sabo Dam (sediment storage and adjustment)
